The Reconstruction and Failure Analysis of The Space Shuttle Columbia

Richard Russell¹, Brain Mayeaux¹, Steven McDanels², Robert Piascik³, Sandeep Shah⁴,
Greg Jerman⁴, Thomas Collins⁵, Warren Woodworth⁶

¹NASA JSC, ²NASA KSC, ³NASA LaRC, ⁴NASA MSFC, ⁵The Boeing Company,
⁶United Space Alliance

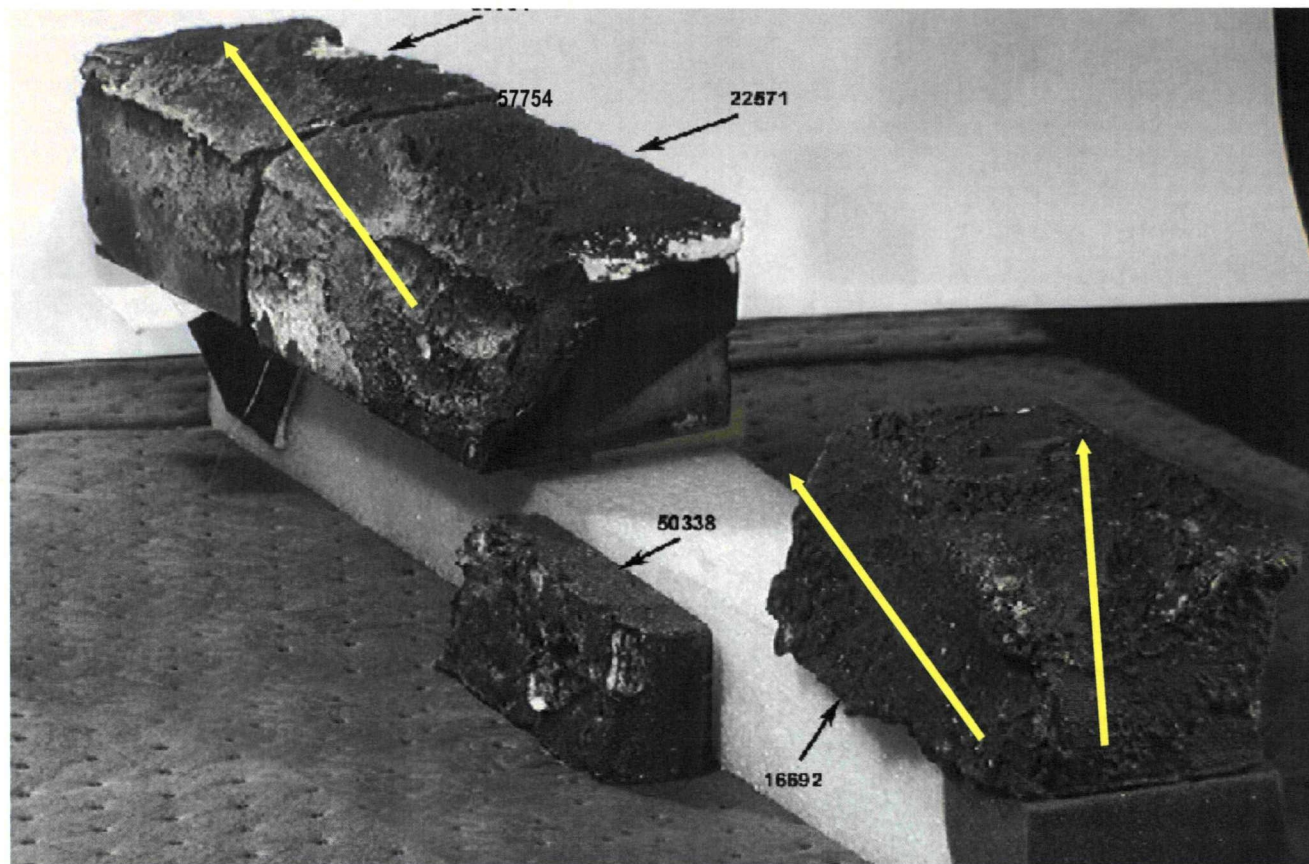
Reconstructed View of Lower C/P 9 Tile

Slumping and erosion patterns suggest plasma flow across the carrier panel tile (from 8 toward 10)

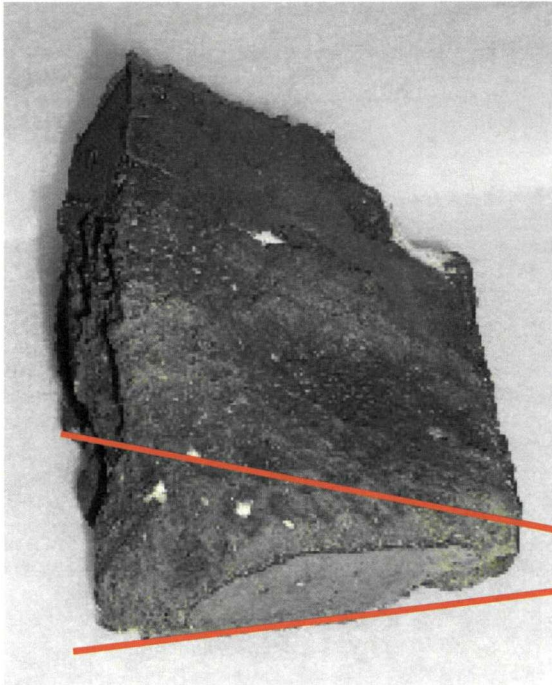
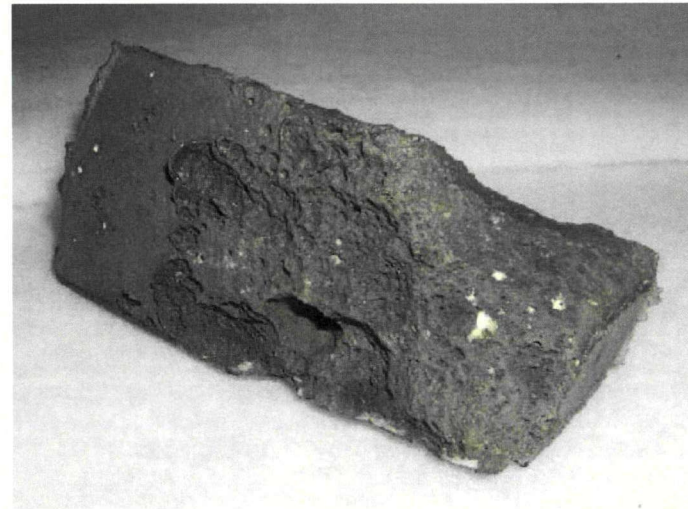
Carrier Panel 8 - Upper

Item 50336 (V070-199715-074)

Slumping and erosion patterns suggest plasma flow out of leading edge cavity (consistent with vent)

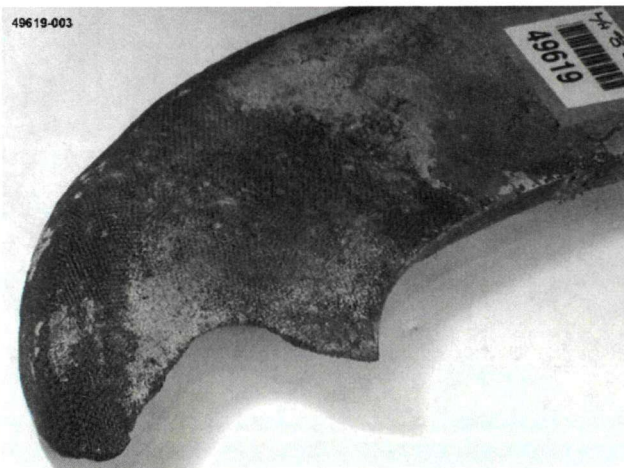
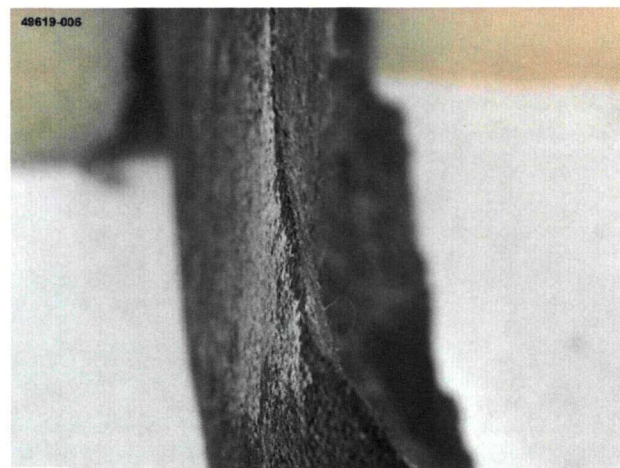
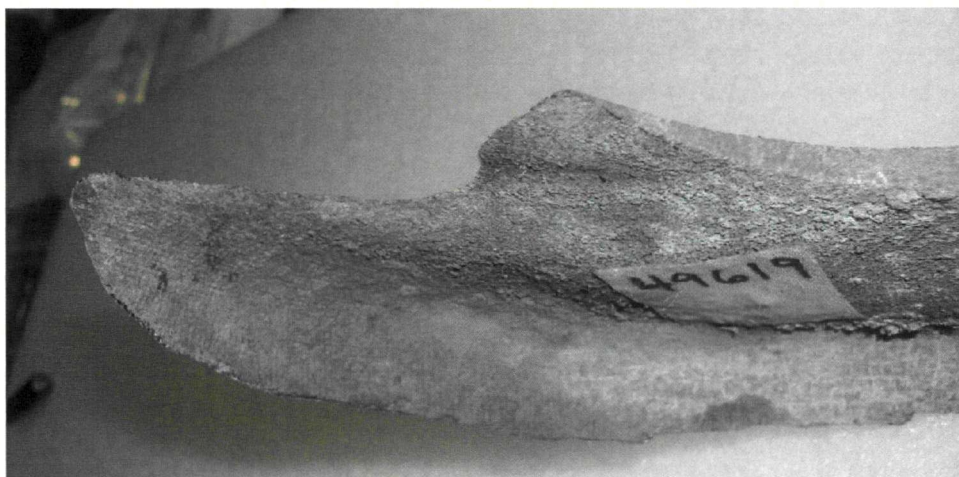
Erosion on Panel 8 Upper Outboard Rib

Item 49619

Close-ups of knife edge,
note fibers not visible on
internal surface of panel
due to deposits.

Rib tapers from design
thickness of .365" to .05".

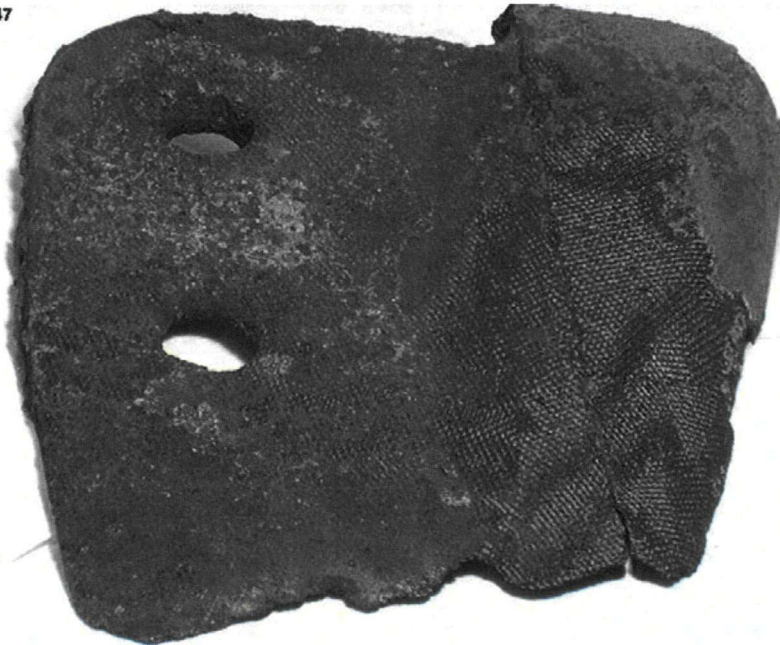
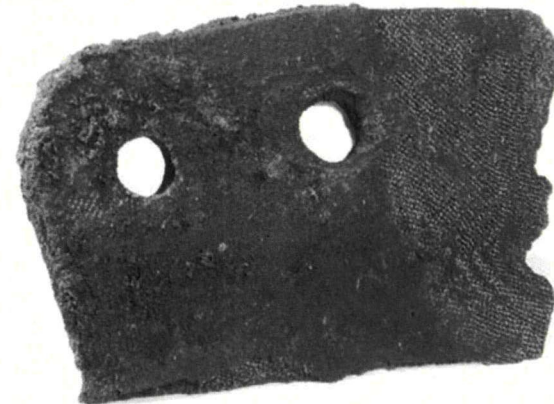
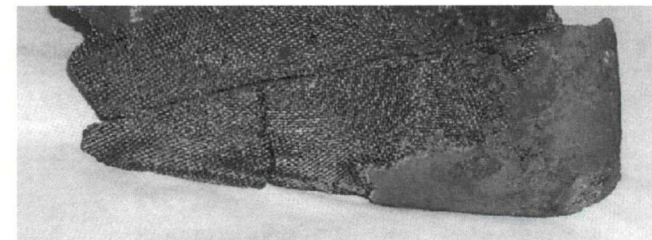
Erosion on Gap Surfaces of Panel 8 Outboard Lug & Matching Heel Piece

Lug fragment tapers from design thickness of .499", to a Knife Edge with a minimum thickness of 0.063"

Heel fragment tapers from design thickness of .233", to a Knife Edge with a minimum thickness of 0.052"

- Matching eroded plies between items 24724 and 58291, shows heat flow external to the panel while panel heel and lug were attached
- Metallic deposits at lug attach points - evidence that metallic deposited after lug no longer attached to fitting
- Inconel bushings missing at holes

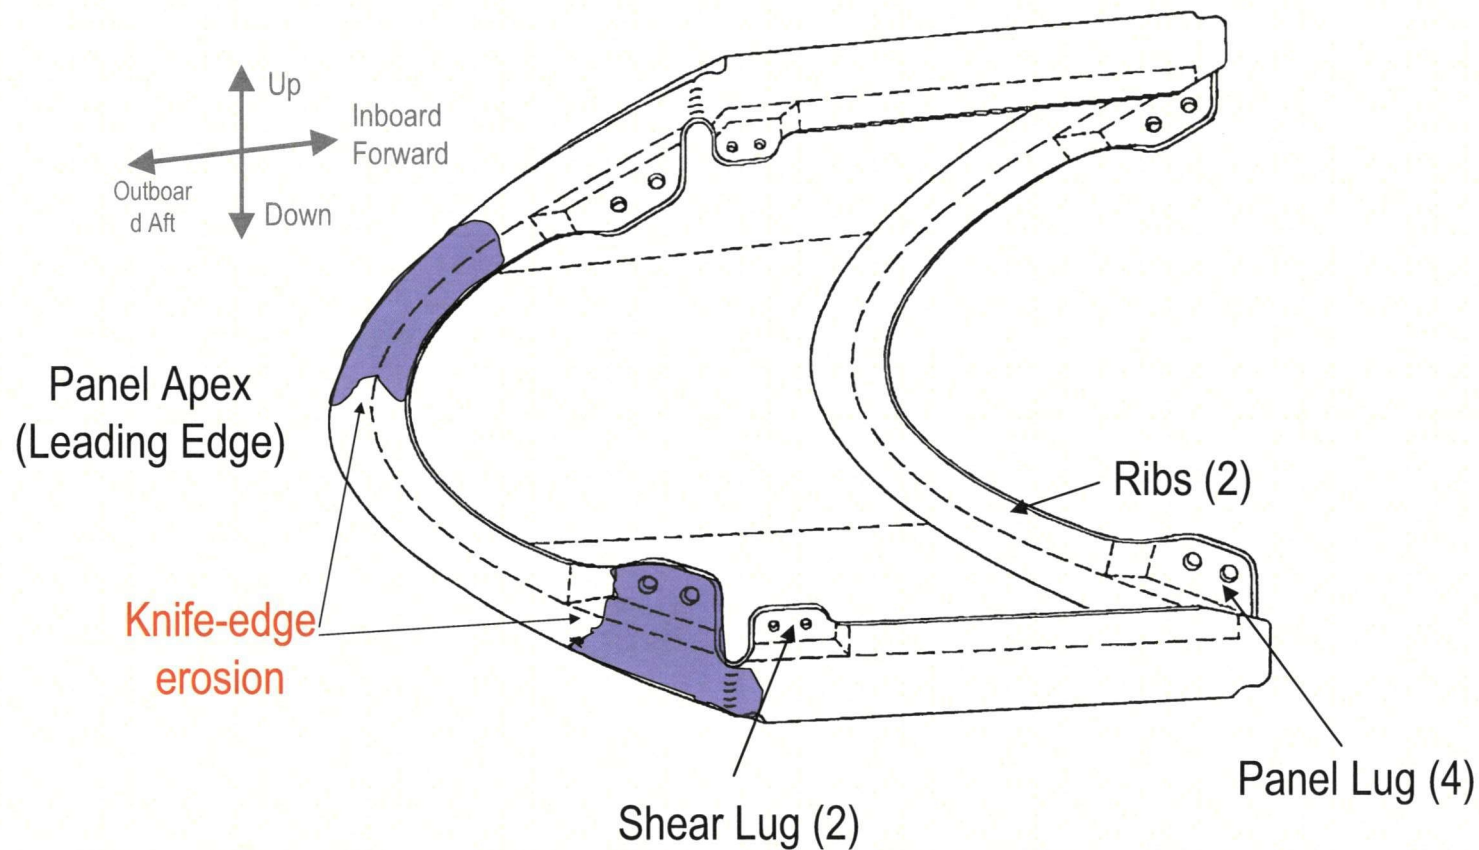
RCC Panel 8 Erosion Features

Erosion indicates prolonged exposure to plasma heating

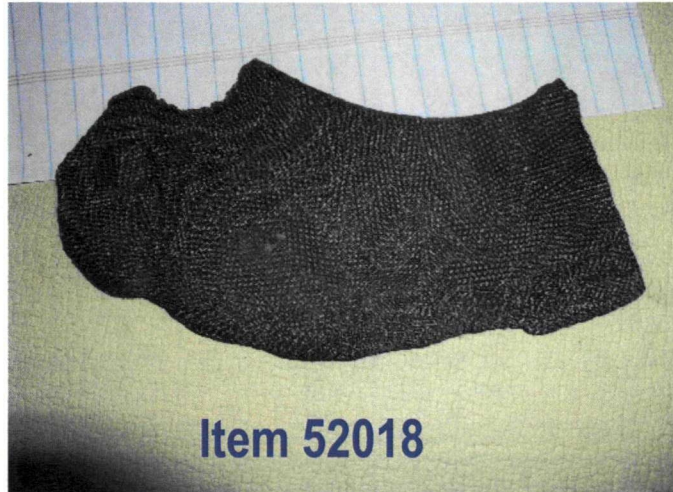
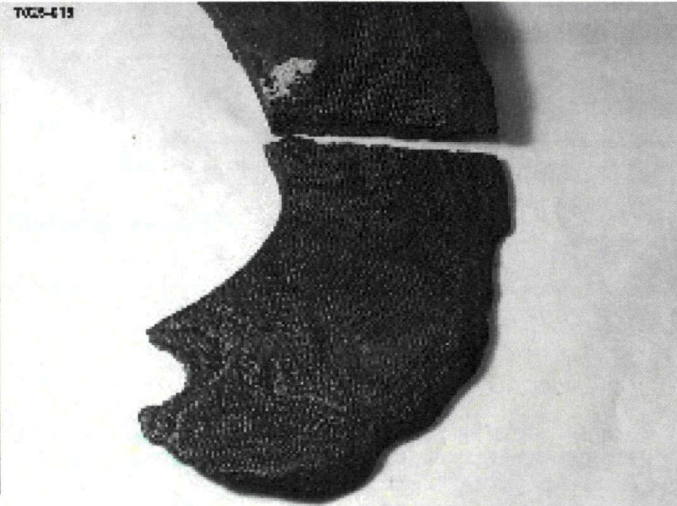
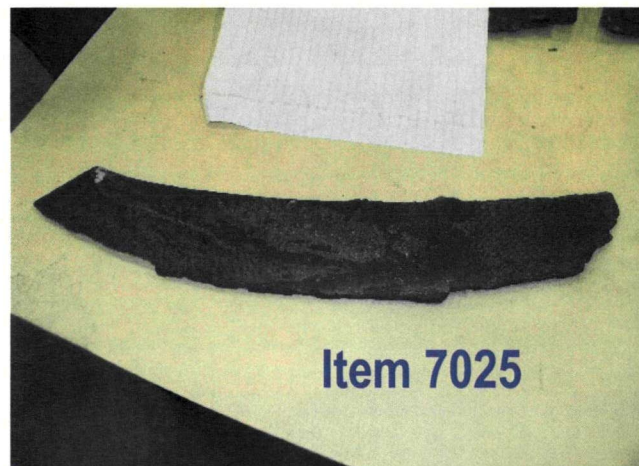
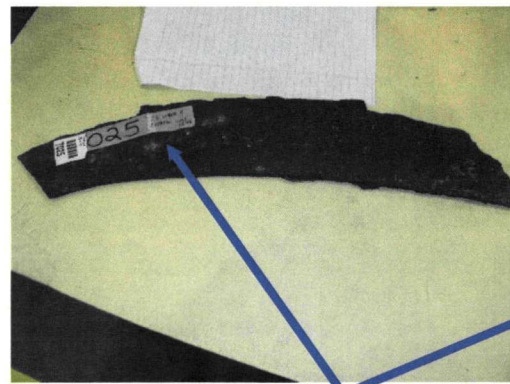
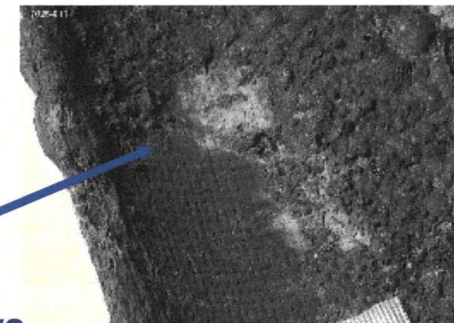
Erosion on Panel 9 Upper Inboard Rib

7025 internal side shows presence of metallic deposits

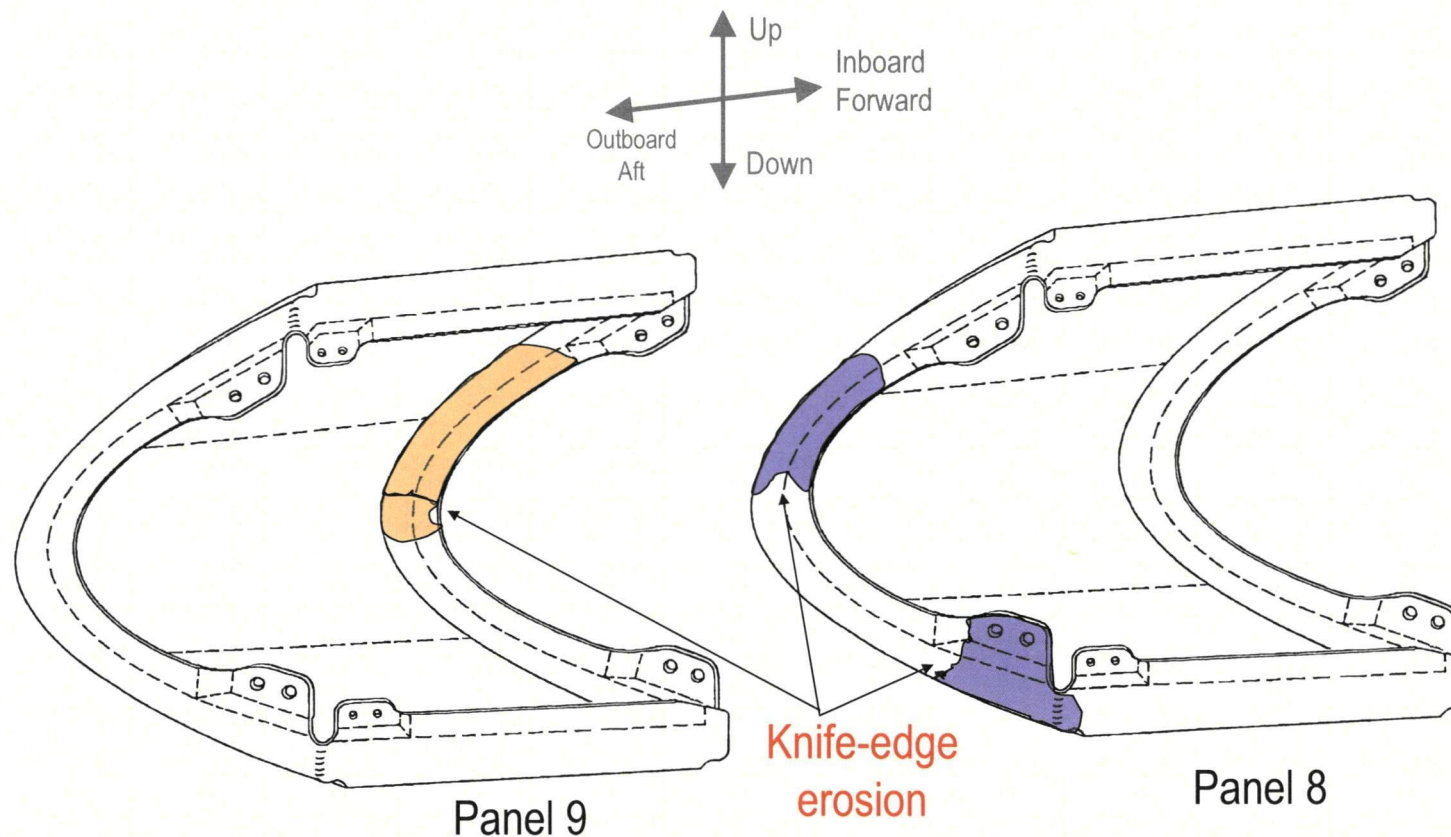
RCC Panels 8 & 9 Erosion Features

Erosion indicates prolonged exposure in the panel 8-9 joint area.

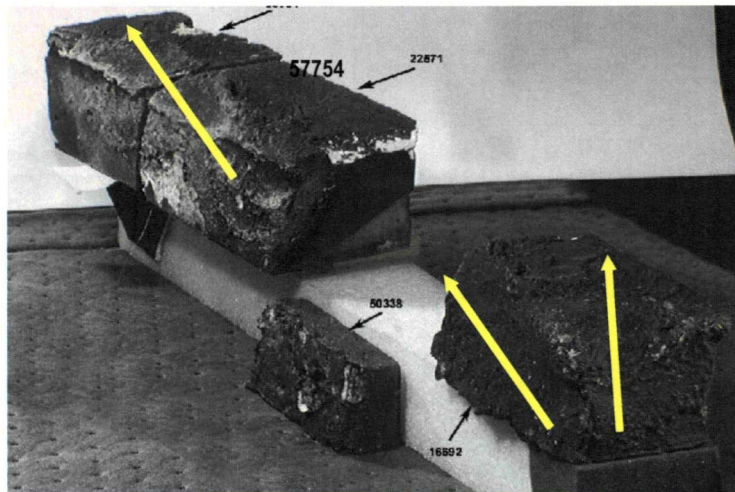
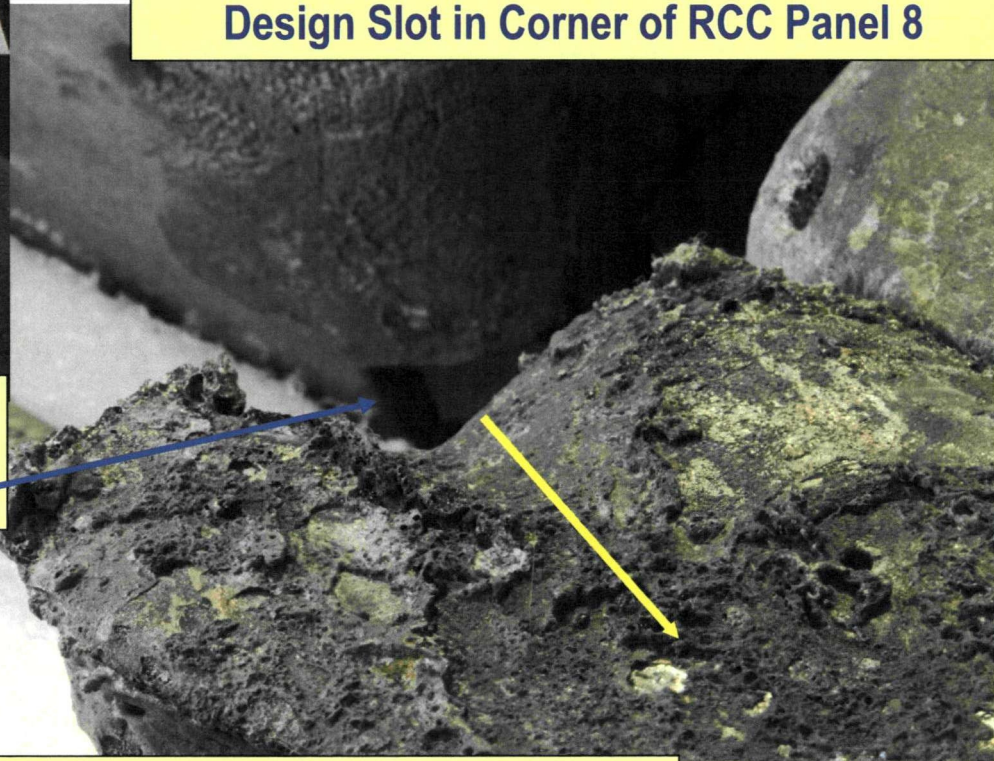
Slumping Source for Carrier Panel 9 Tile was Revealed

Slumping and erosion patterns suggest plasma flow across the carrier panel tile (from 8 toward 10)

Slumping of C/P 9 Tile #1 Corresponds with Design Slot in Corner of RCC Panel 8

Evidence of Hot Gas Flow Exiting Design Slot Indicates Significant Breach Was Into Panel 8

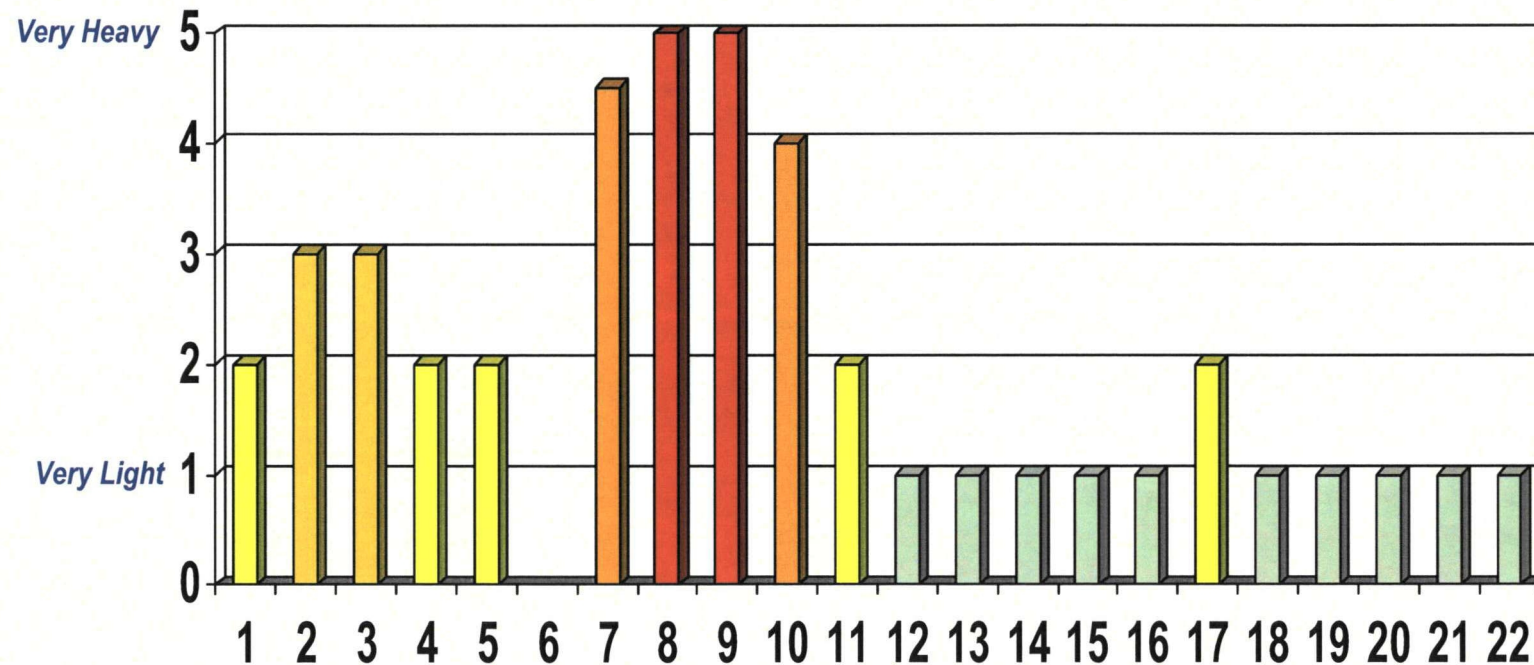
Relative Metallic Deposition on L/H Wing Materials

**Distribution of metallic deposition volume
was centered around panels 8 & 9**

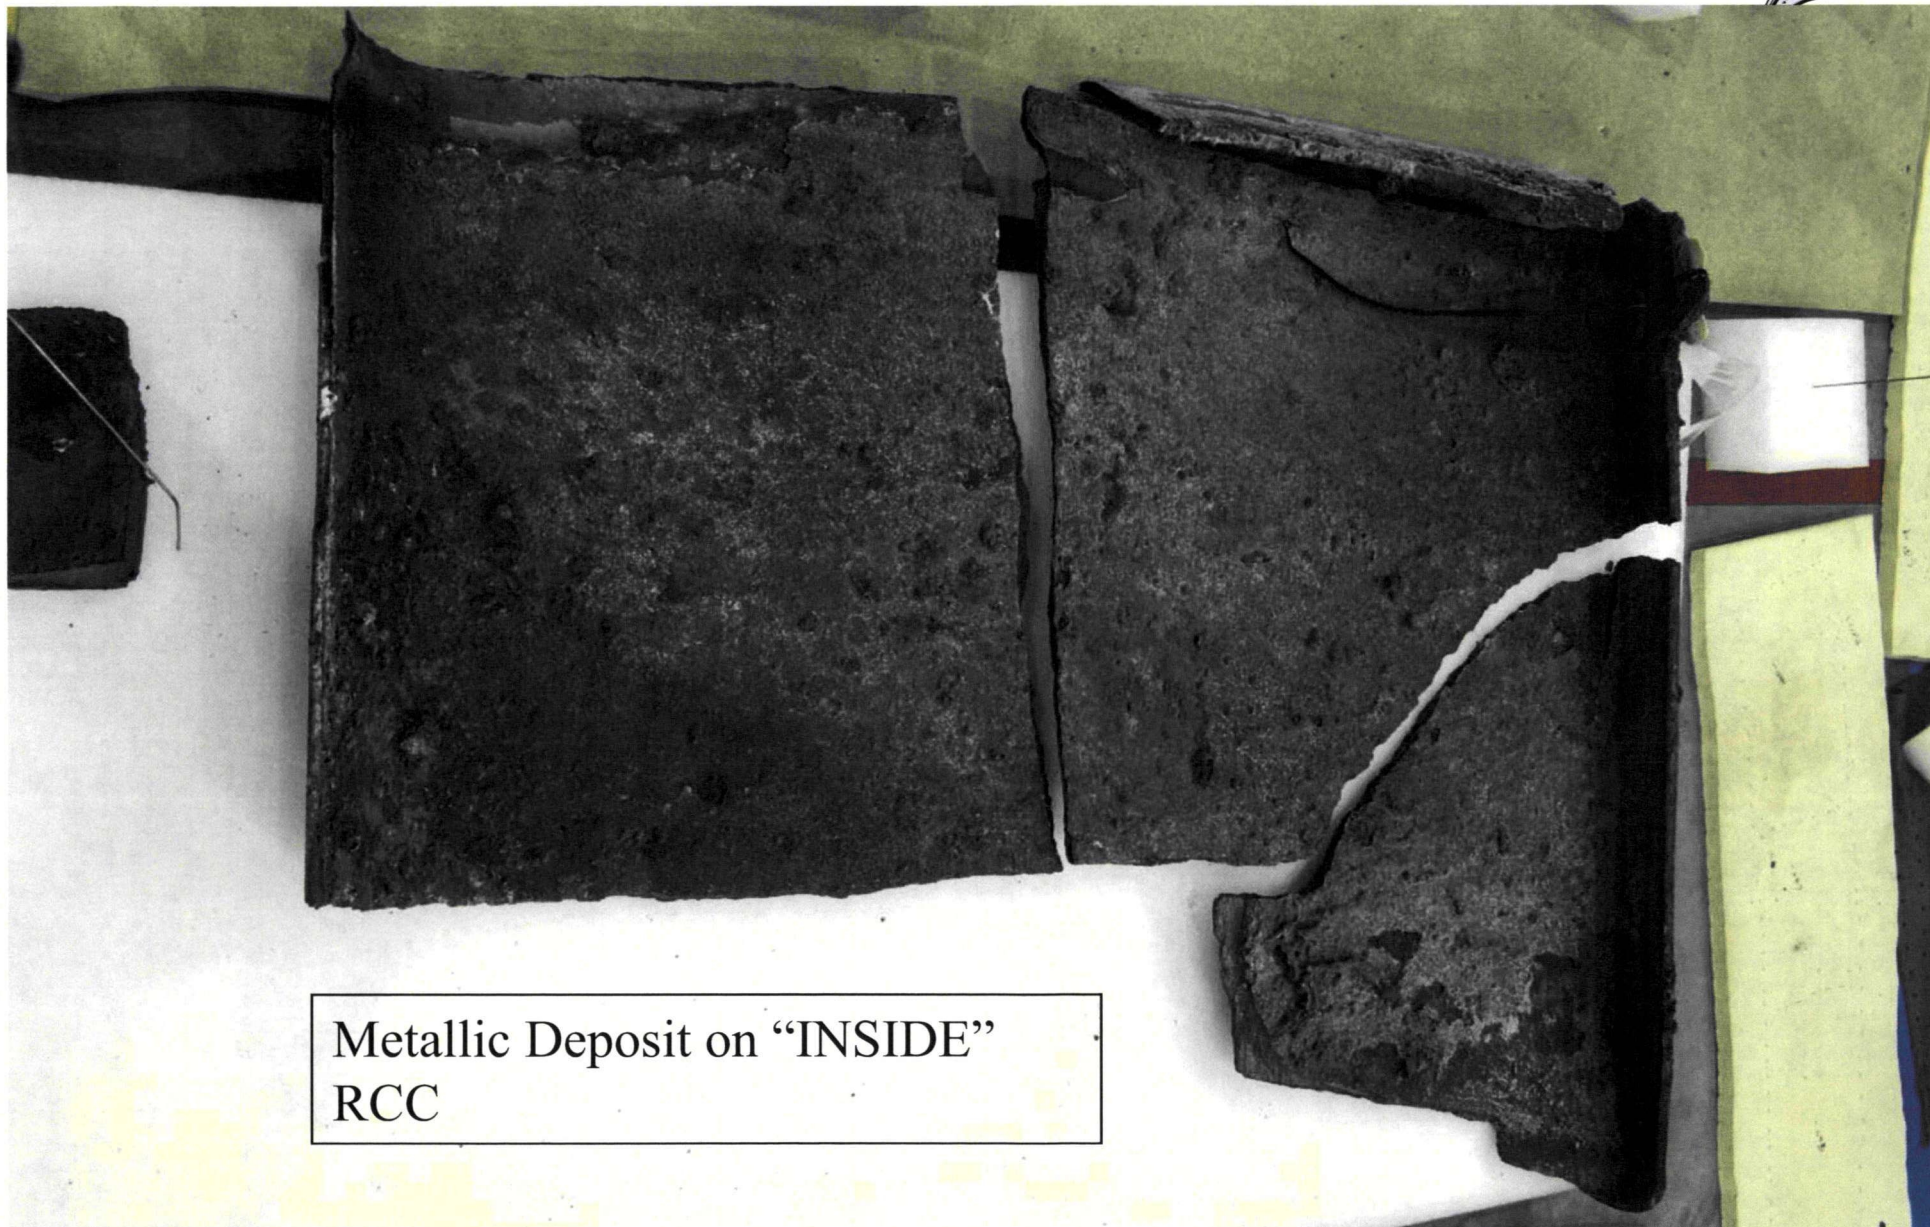
Metallic Deposit Example, LH RCC 8

Metallic Deposit on "INSIDE"
RCC

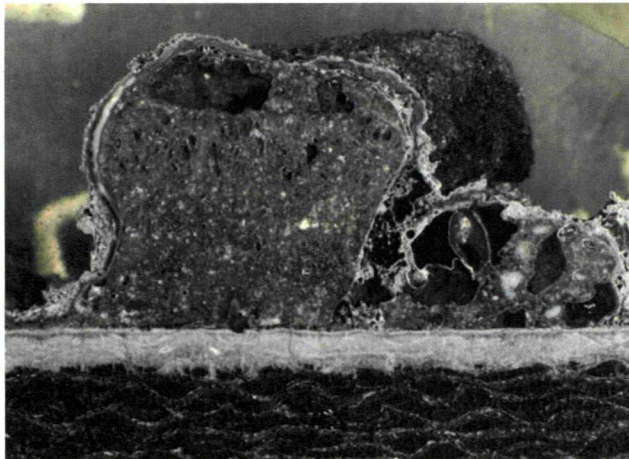
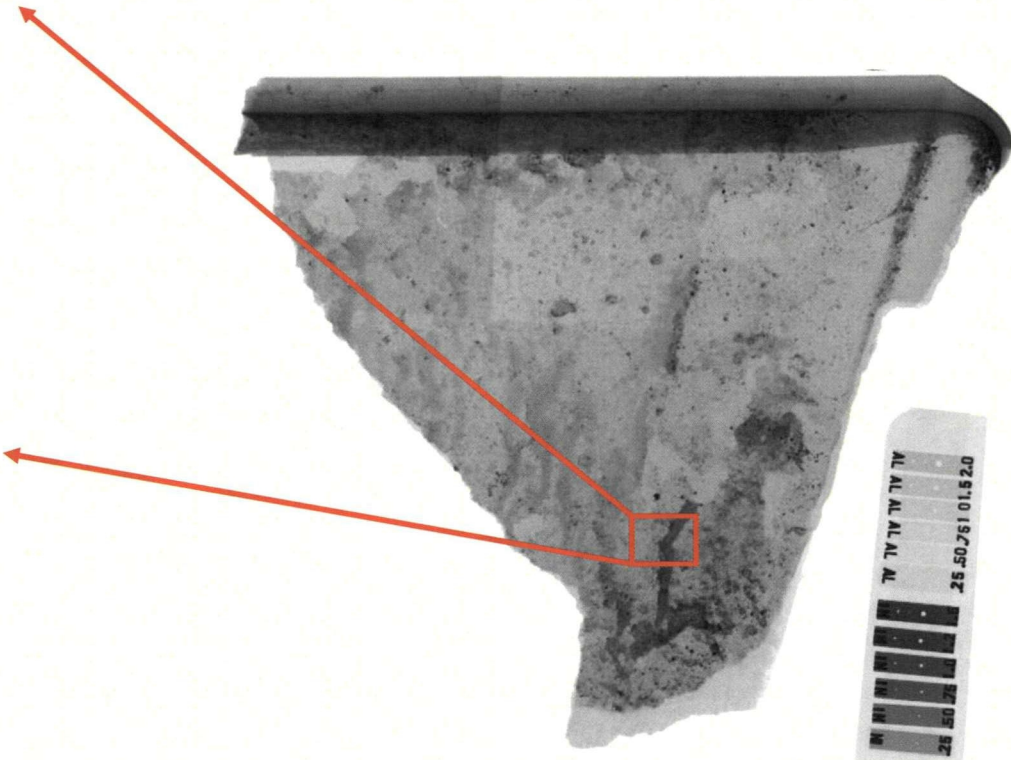
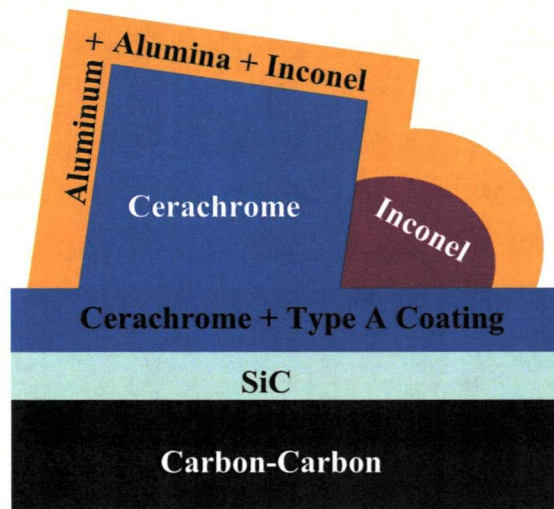
LH RCC 8 – Deposit Feature: Thick Tear Shaped

Item 43709, Sample 2A1

Radiograph of Item 43709

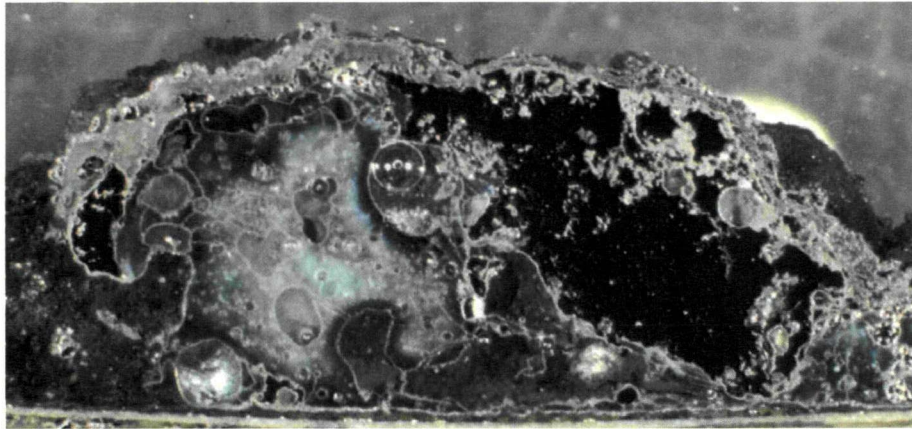
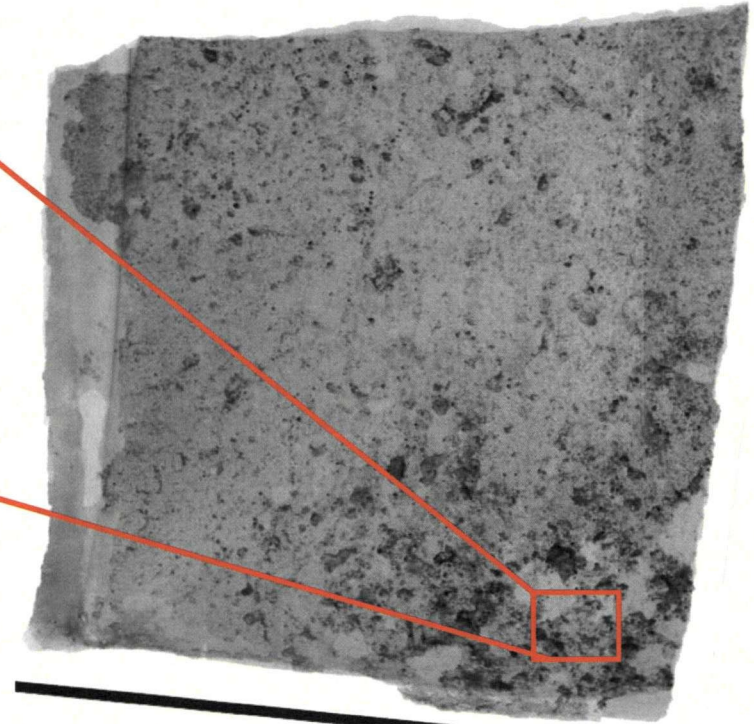
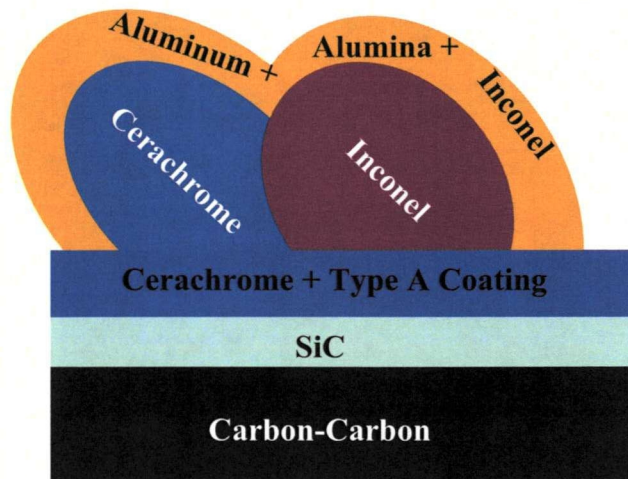
LH RCC 8 – Deposit Feature: Thick Globules

Item 2200, Sample 6A1

Radiograph of Item 2200

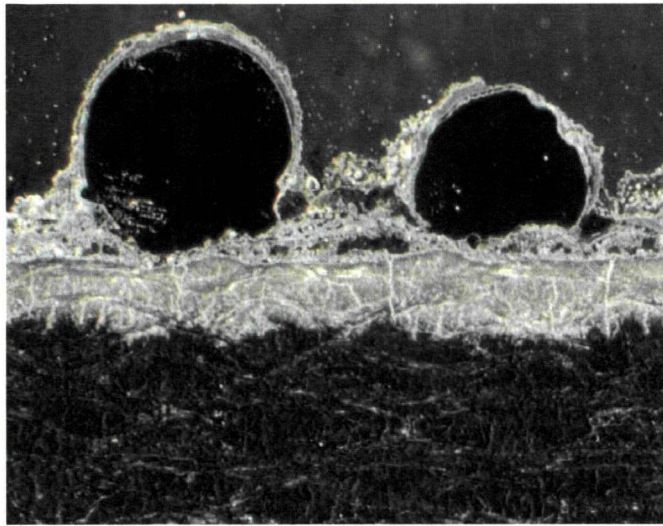
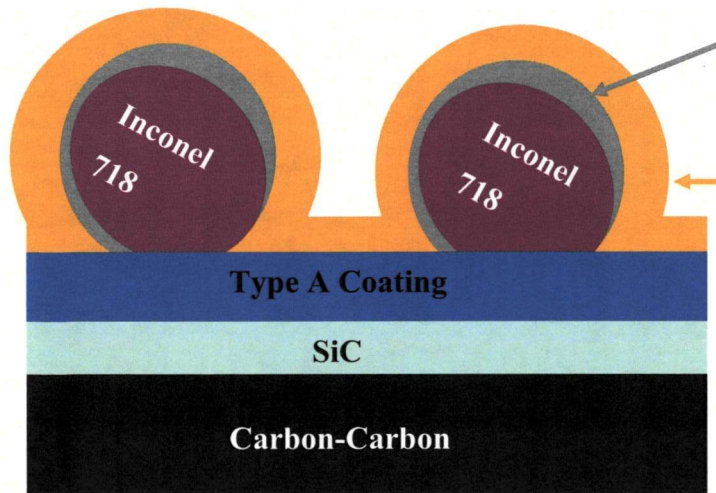
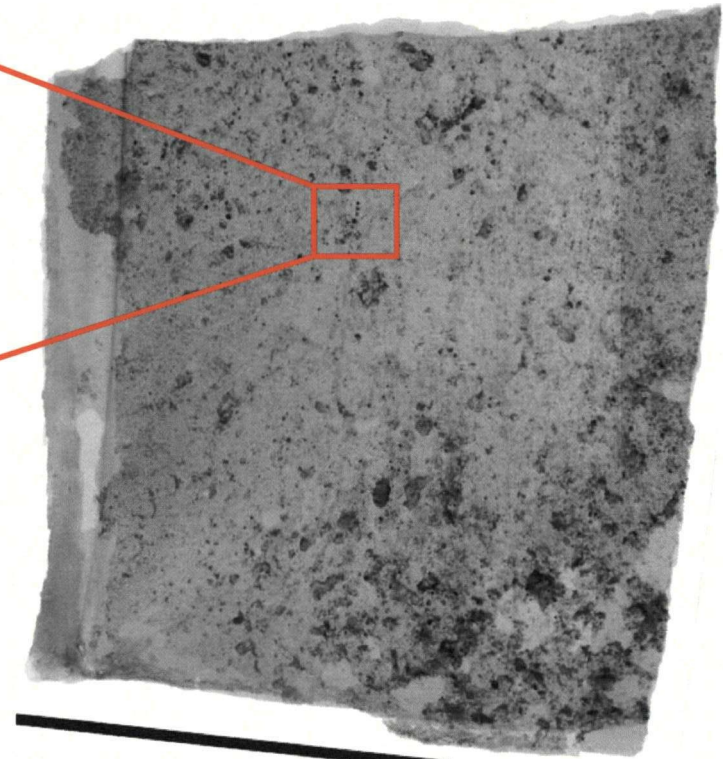
LH RCC 8 – Deposit Feature: Spheroids

Item 2200, Sample 6C1

Alumina

Aluminum
+Alumina
+Inconel

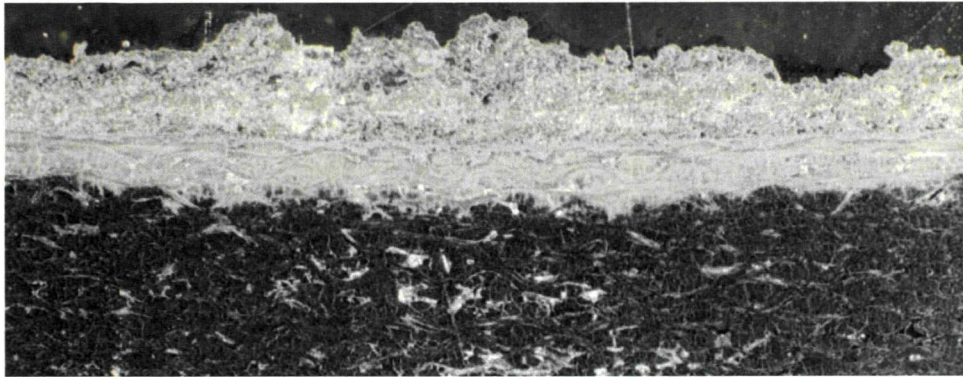
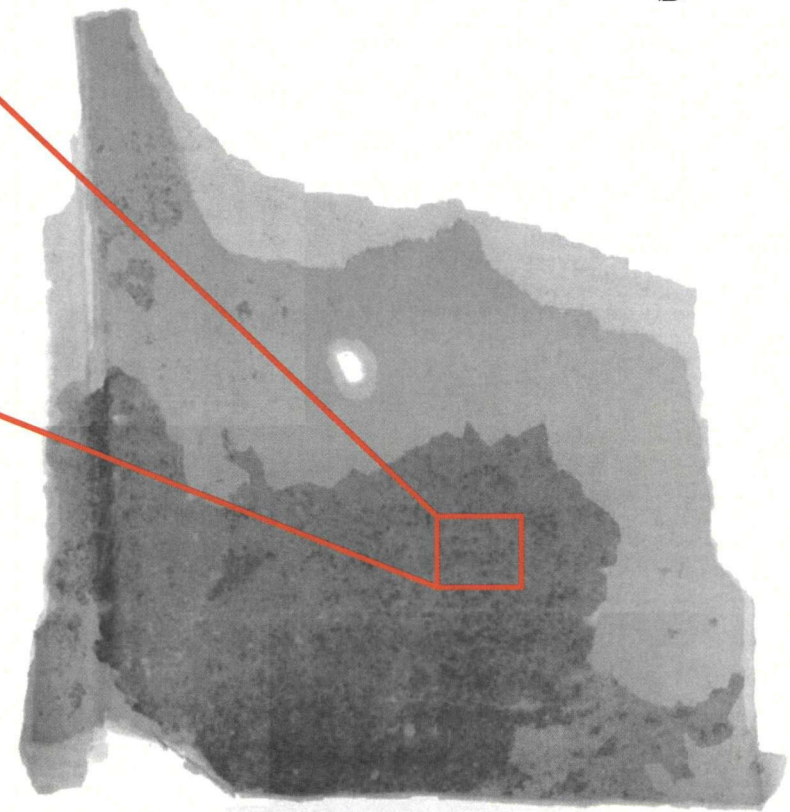
LH RCC 8 – Deposit Feature: Uniform Deposit

Item 16523, Sample 4A1

Cerachrome+Aluminum+Inconel+Alumina

Aluminum+Inconel+Cerachrome+Type A Coating

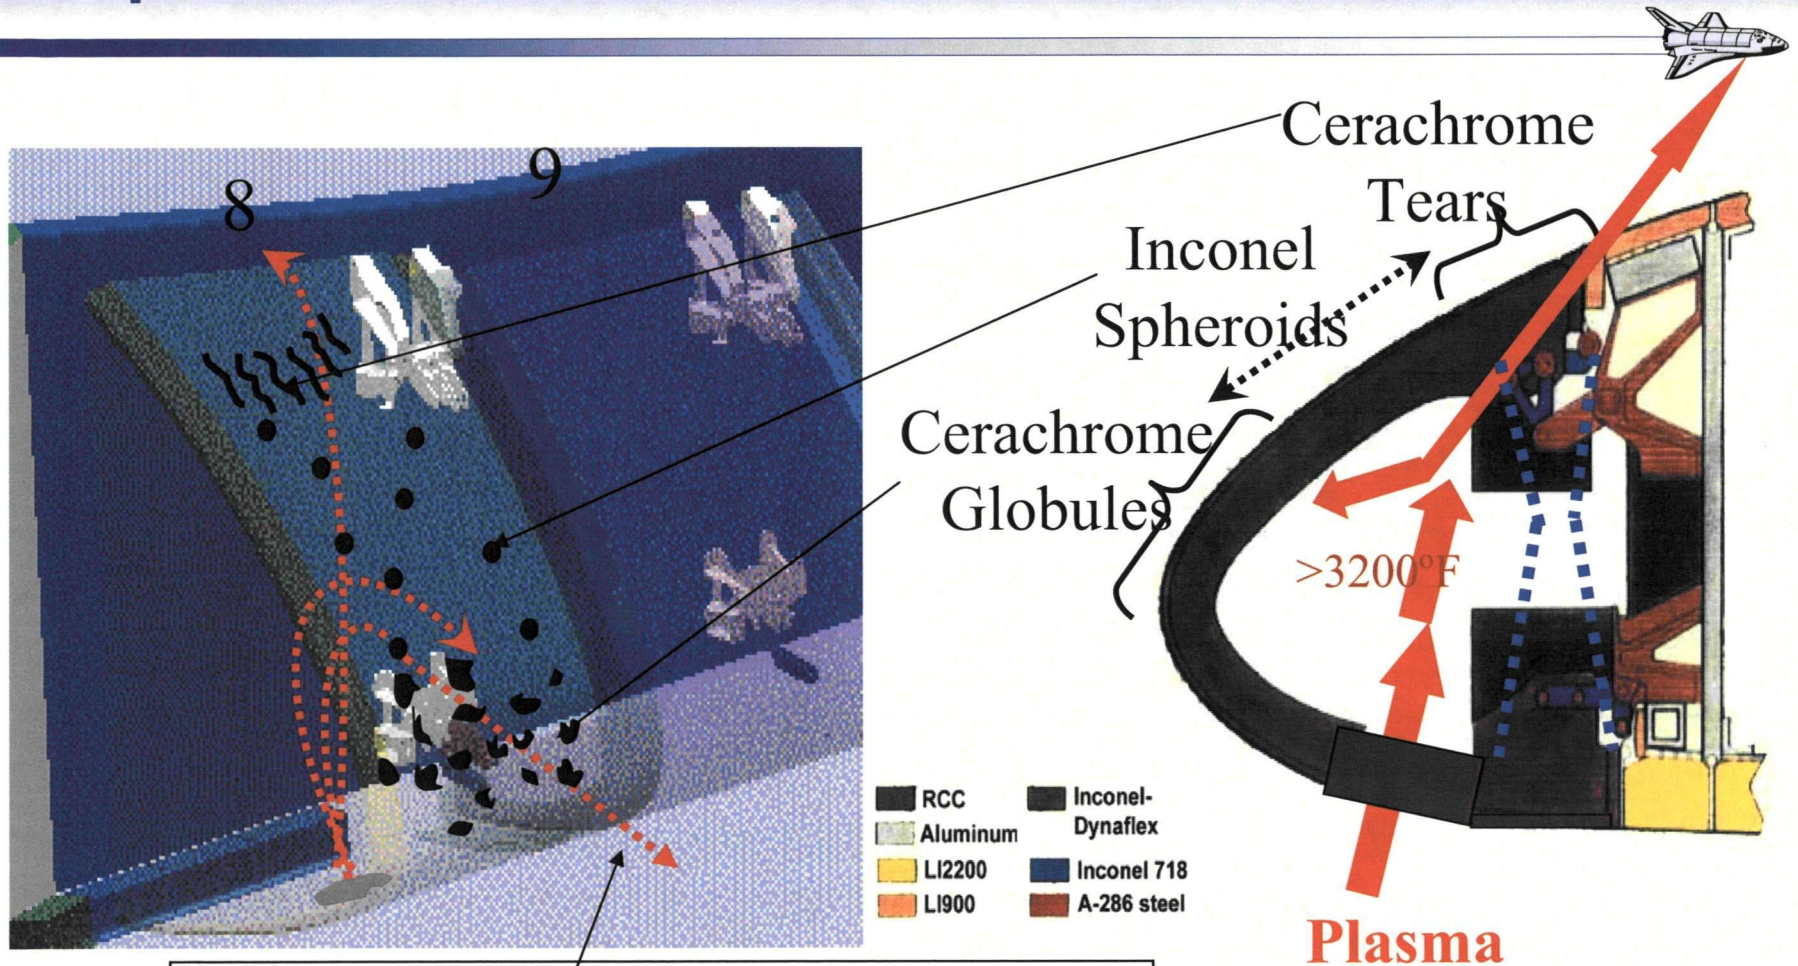
Proposed Breach Location and Plasma Flow

Flow Exiting through RCC 8 on to lower Carrier Panel 9 tiles

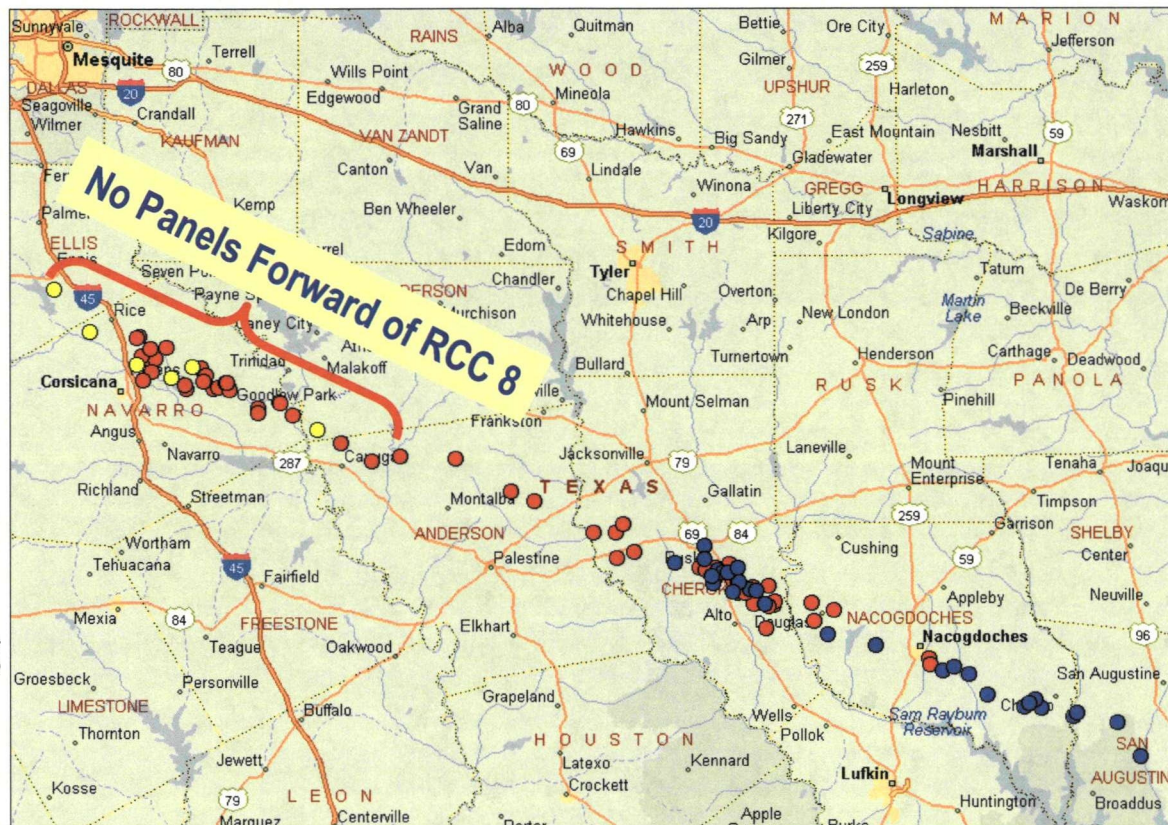
Corroborating Information - RCC Panel Debris Locations

- Panels at RCC 8 and Aft Dropped First
- All Eroded RCC Pieces (in 8 & 9) Found to the West
- R/H Wing Panels and L/H Wing Panels 1-8 Found to the East

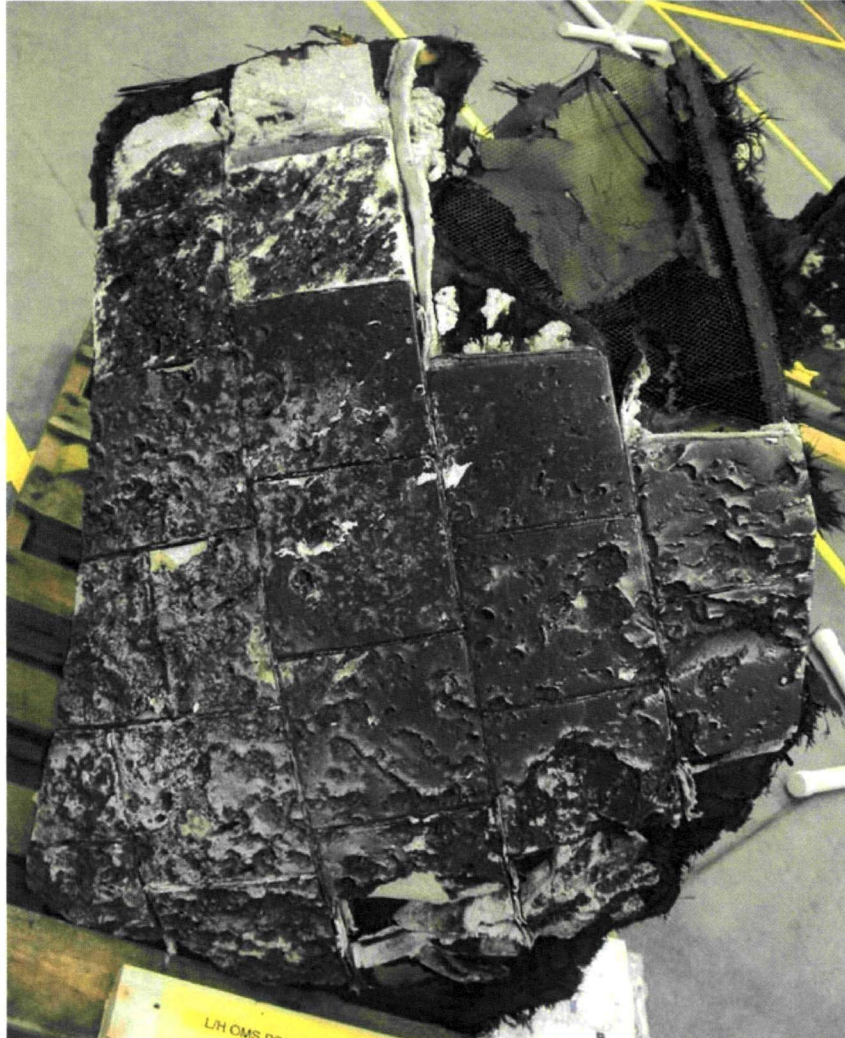
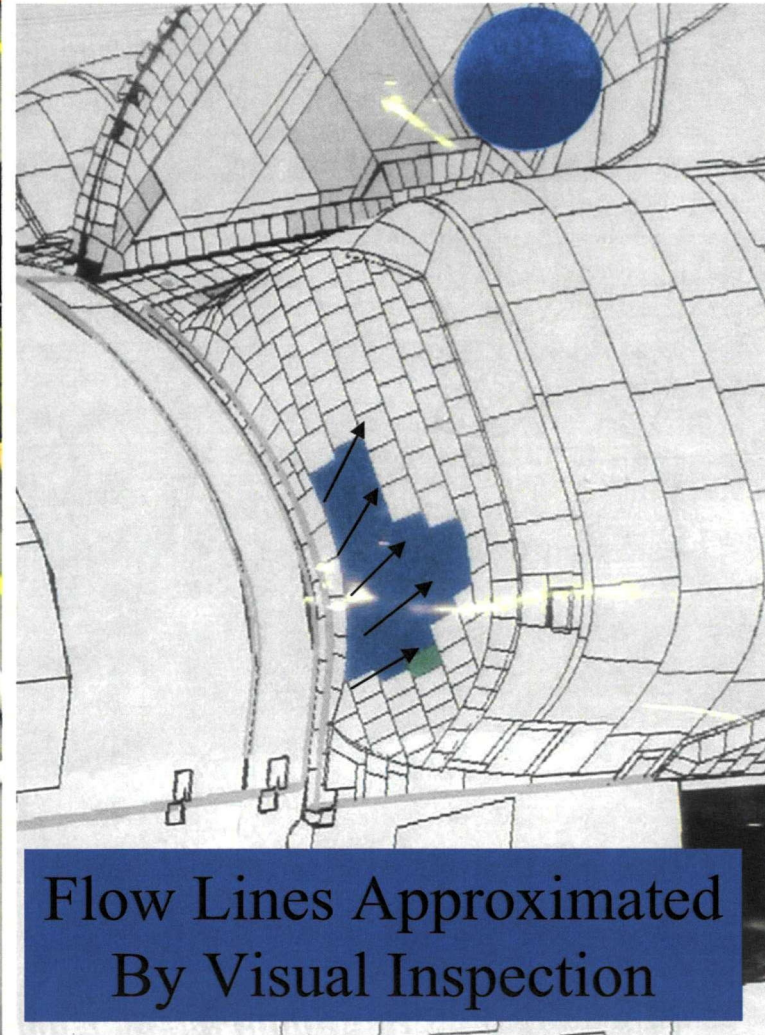
Corroborating Information – LH OMS Pod Analysis

Flow Lines Approximated
By Visual Inspection
